**Flood Control Project Maintenance
Levee Inspections**

Maintenance Issue Types Only, Levee Inspection Report By Mile - Fall 2018

Reclamation District No. 2068 Yolano

Waterway	Bank	Unit Miles	Inspection Start/End	Inspector
Unit No. 01 Yolo Bypass	Right	5.48	10/18/2018 10/18/2018	David Julian

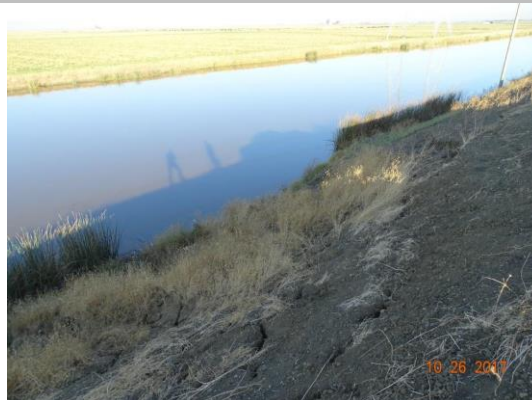
Photo 1 of 2 : FA_2018_RD2068_193_20_20180925_00012.jpg

LM Start	3.16	Rating **	A/W	Issue No.	20
LM End	3.19	Issue Type +	Ma	Location *	LS
Category	Earthen Levee		GPS Latitude/Longitude		
			Start	End	
Item	Slope Stability		38.362765°	38.362278°	
			-121.694040°	-121.694050°	
DWR ID	DWR_RD2068_01_f_2018_20				
Comment Code					
S1 : Repair slope instability.					
Inspector Comment					
Repair the slope instability.

Repair the slope instability.

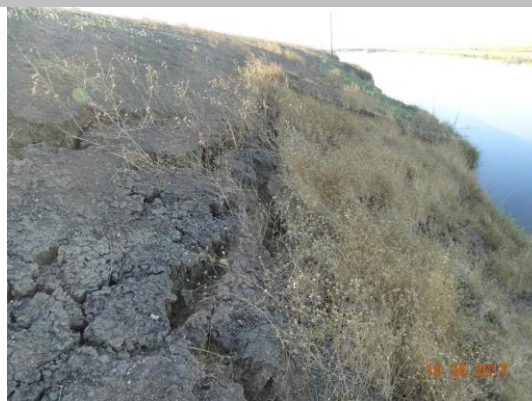
Photo 2 of 2 : FA_2018_RD2068_193_20_20180925_00013.jpg

LM Start	3.16	Rating **	A/W	Issue No.	20 (cont)	
LM End	3.19	Issue Type +	Ma	Location *	LS	
Category	Earthen Levee			GPS Latitude/Longitude		
				Start		End
Item	Slope Stability			38.362765 °		38.362278 °
				-121.694040 °		-121.694050 °
DWR ID	DWR_RD2068_01_f_2018_20					
Comment Code						
S1 : Repair slope instability.						
Inspector Comment						
Repair the slope instability.

Repair the slope instability.

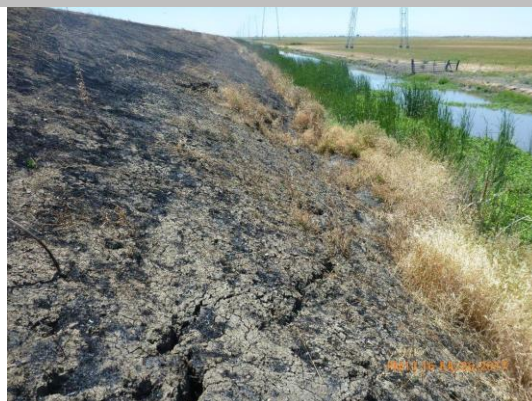
Photo 1 of 3 : FA_2018_RD2068_193_27_20180925_00014.jpg

LM Start	3.73	Rating **	A/W	Issue No.	27
LM End	3.74	Issue Type +	Ma	Location *	
Category	Supplemental			GPS Latitude/Longitude	
				Start	End
Item	2017 Storm Damage			38.354500 °	38.354400 °
				-121.694000 °	-121.694000 °
DWR ID	DWR_RD2068_01_f_2017_27				
Comment Code					
Inspector Comment					
Levee Evaluation Comments					
Description:The damage consists of scour, cracking, and sloughing of the lower landside levee slope approximately 47 feet in length along the west (right) bank of Shag Slough (Yolo Bypass). See attached pages for photos.					
Site ID No:462					
Site Designation:LMA-289					
Repair Type: Stability					
Rating:Serious					
Field Date:7/26/2017					
Notes: 2' feet vertical cut on waterside levee toe from wavewash; site combined with LMA- 288 in field.

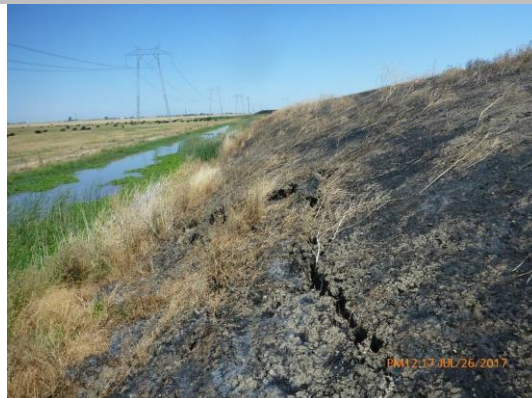
Photo 3 of 3 : FA_2018_RD2068_193_27_20180925_00016.jpg

LM Start	3.73	Rating **	A/W	Issue No.	27 (cont)							
LM End	3.74	Issue Type +	Ma	Location *								
Category	Supplemental		GPS Latitude/Longitude									
			Start	End								
Item	2017 Storm Damage		38.354500°	38.354400°								
			-121.694000°	-121.694000°								
DWR ID	DWR_RD2068_01_f_2017_27											
Comment Code												
Inspector Comment												
Levee Evaluation Comments Description: The damage consists of scour, cracking, and sloughing of the lower landside levee slope approximately 47 feet in length along the west (right) bank of Shag Slough (Yolo Bypass). See attached pages for photos. Site ID No: 462 Site Designation: LMA-289 Repair Type: Stability Rating: Serious Field Date: 7/26/2017 Notes: 2' feet vertical cut on waterside levee toe from wavewash; site combined with LMA- 288 in field.

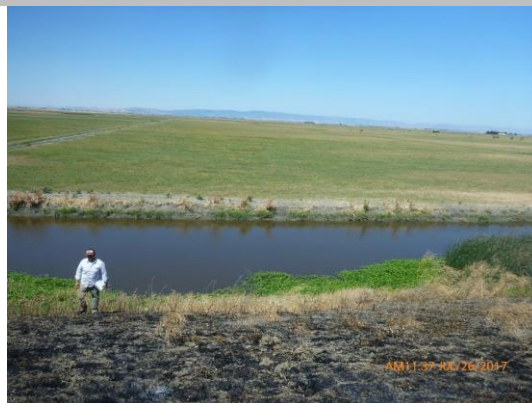
Photo 1 of 3 : FA_2018_RD2068_193_28_20180925_00017.jpg

LM Start	4.30	Rating **	A/W	Issue No.	28							
LM End	4.31	Issue Type +	Ma	Location *								
Category	Supplemental		GPS Latitude/Longitude									
			Start	End								
Item	2017 Storm Damage		38.346200°	38.346100°								
			-121.694000°	-121.694000°								
DWR ID	DWR_RD2068_01_f_2017_28											
Comment Code												
Inspector Comment												
Levee Evaluation Comments Description: The damage consists of scour, cracking, and sloughing of the lower landside levee slope approximately 30 feet in length along the west (right) bank of Shag Slough (Yolo Bypass). See attached pages for photos. Site ID No: 463 Site Designation: LMA-290 Repair Type: Stability Rating: Serious Field Date: 7/26/2017 Notes: 3' feet vertical cut at waterside levee toe from wavewash

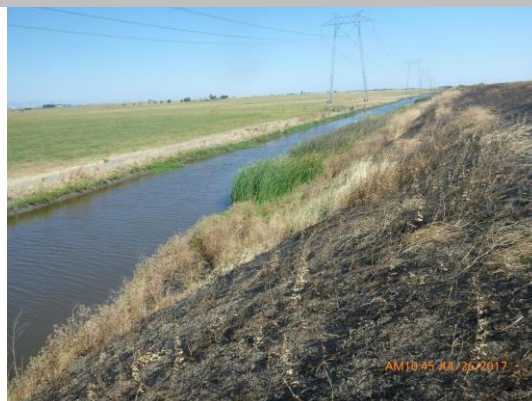
Photo 1 of 3 : FA_2018_RD2068_193_29_20180925_00020.jpg

LM Start	4.39	Rating **	A/W	Issue No.	29
LM End	4.40	Issue Type +	Ma	Location *	
Category	Supplemental			GPS Latitude/Longitude	
				Start	End
Item	2017 Storm Damage			38.344900 °	38.344800 °
				-121.694000 °	-121.694000 °
DWR ID	DWR_RD2068_01_f_2017_29				
Comment Code					
Inspector Comment					
Levee Evaluation Comments					
Description:The damage consists of scour, cracking, and sloughing of the lower landside levee slope approximately 30 feet in length along the west (right) bank of Shag Slough (Yolo Bypass). See attached pages for photos.					
Site ID No:464					
Site Designation:LMA-291					
Repair Type: Stability					
Rating:Serious					
Field Date:7/26/2017					
Notes: 2' feet vertical cut at waterside levee toe from wavewash

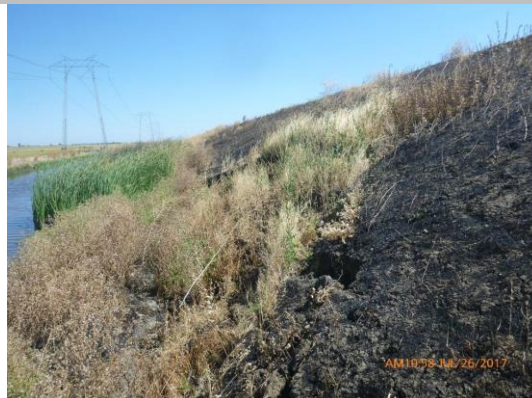
Photo 3 of 3 : FA_2018_RD2068_193_29_20180925_00022.jpg

LM Start	4.39	Rating **	A/W	Issue No.	29 (cont)	
LM End	4.40	Issue Type +	Ma	Location *		
Category	Supplemental			GPS Latitude/Longitude		
				Start	End	
Item	2017 Storm Damage			38.344900°	38.344800°	
				-121.694000°	-121.694000°	
DWR ID	DWR_RD2068_01_f_2017_29					
Comment Code						
Inspector Comment						
Levee Evaluation Comments						
Description:The damage consists of scour, cracking, and sloughing of the lower landside levee slope approximately 30 feet in length along the west (right) bank of Shag Slough (Yolo Bypass). See attached pages for photos.						
Site ID No:464						
Site Designation:LMA-291						
Repair Type: Stability						
Rating:Serious						
Field Date:7/26/2017						
Notes: 2' feet vertical cut at waterside levee toe from wavewash

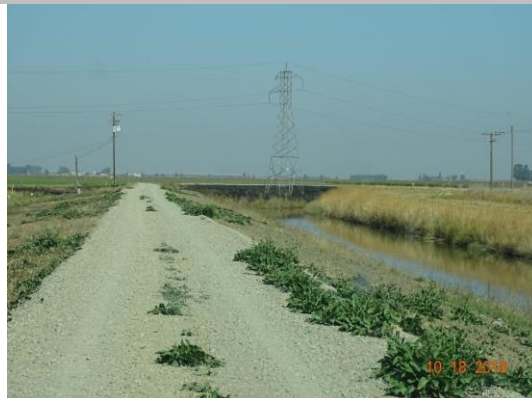
Photo 1 of 2 : FA_2018_RD2068_194_11_20181019_00008.jpg

LM Start	0.01	Rating **	A/W	Issue No.	11
LM End	1.04	Issue Type +	Ma	Location *	CR
Category	Earthen Levee			GPS Latitude/Longitude	
				Start	End
Item	Vegetation			38.358313 °	38.372907 °
				-121.740385 °	-121.738888 °
DWR ID	DWR_RD2068_02_s_2017_11				
Comment Code					
V9 : Keep the crown roadway free of vegetation.					
Inspector Comment					
Vegetation on crown is currently acceptable, but should be monitored and controlled before vegetation further establishes.

View looking upstream at vegetation starting to establish on the crown (October 2018).

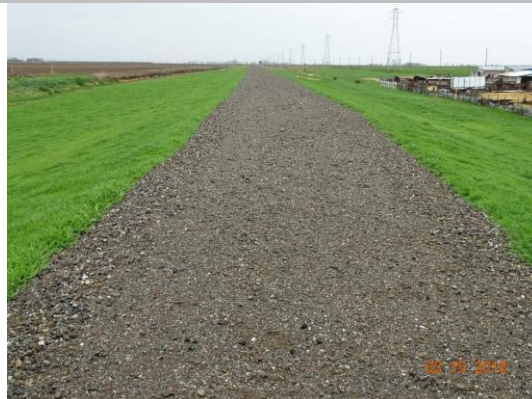
Photo 2 of 2 : FA_2018_RD2068_194_11_20180925_00001.jpg

Lack of crown vegetation looking north from LM 1.02.

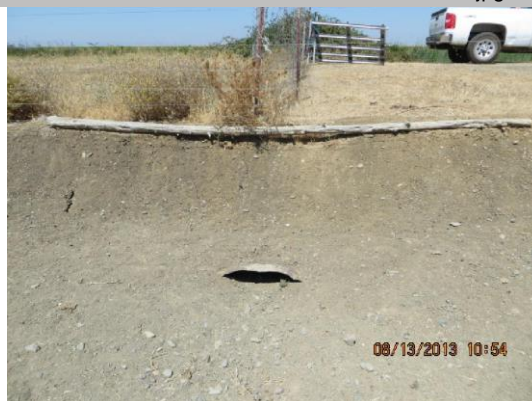
Photo 1 of 1 : UCIP_FA_2018_42725_29680.jpg

Comment Code						
Inspector Comment						
FS_ID:42725						
DS_ID:19352						
EP_NO: 10164						
Repair Type: Non-Urgent						
Crossing Status: Found						
UCIP Comments: 09/14/2017 ABO issued as Permit No. 10164 defines the 48-inch pipe as a drainpipe. (DWR UCIP - O. Magana)						
08/13/2013 Appears abandoned and if so should be done properly.						
Pipe burried except for small opening. (DWR UCIP - W. Wylie)						
FIELD_STRUCT_DESC: *ABANDONED* 48-inch corrugated metal drainage pipe through the levee, 4 feet below the crown. (48-inch pipe [HLM 3.20] authorized under Automatic Board Order (ABO) issued as Permit No. 10164, 1974 - Reclamation District No. 2068). [Additional Reference(s): DWR Levee Log, 1992. USACE Sacramento O&M Manual 109, April 1962, (HLM 3.20)].						
FS Date: 8/13/2013

Pipe buried but visible at toe of east side of levee.
